Investigation into the impact of sewage effluent discharges on water quality in the Freshwater East area, Pembrokeshire

August 2012

Environment Agency Wales. 2012. Hydrogeological assessment of Freshwater East, Pembrokeshire. Internal Report.

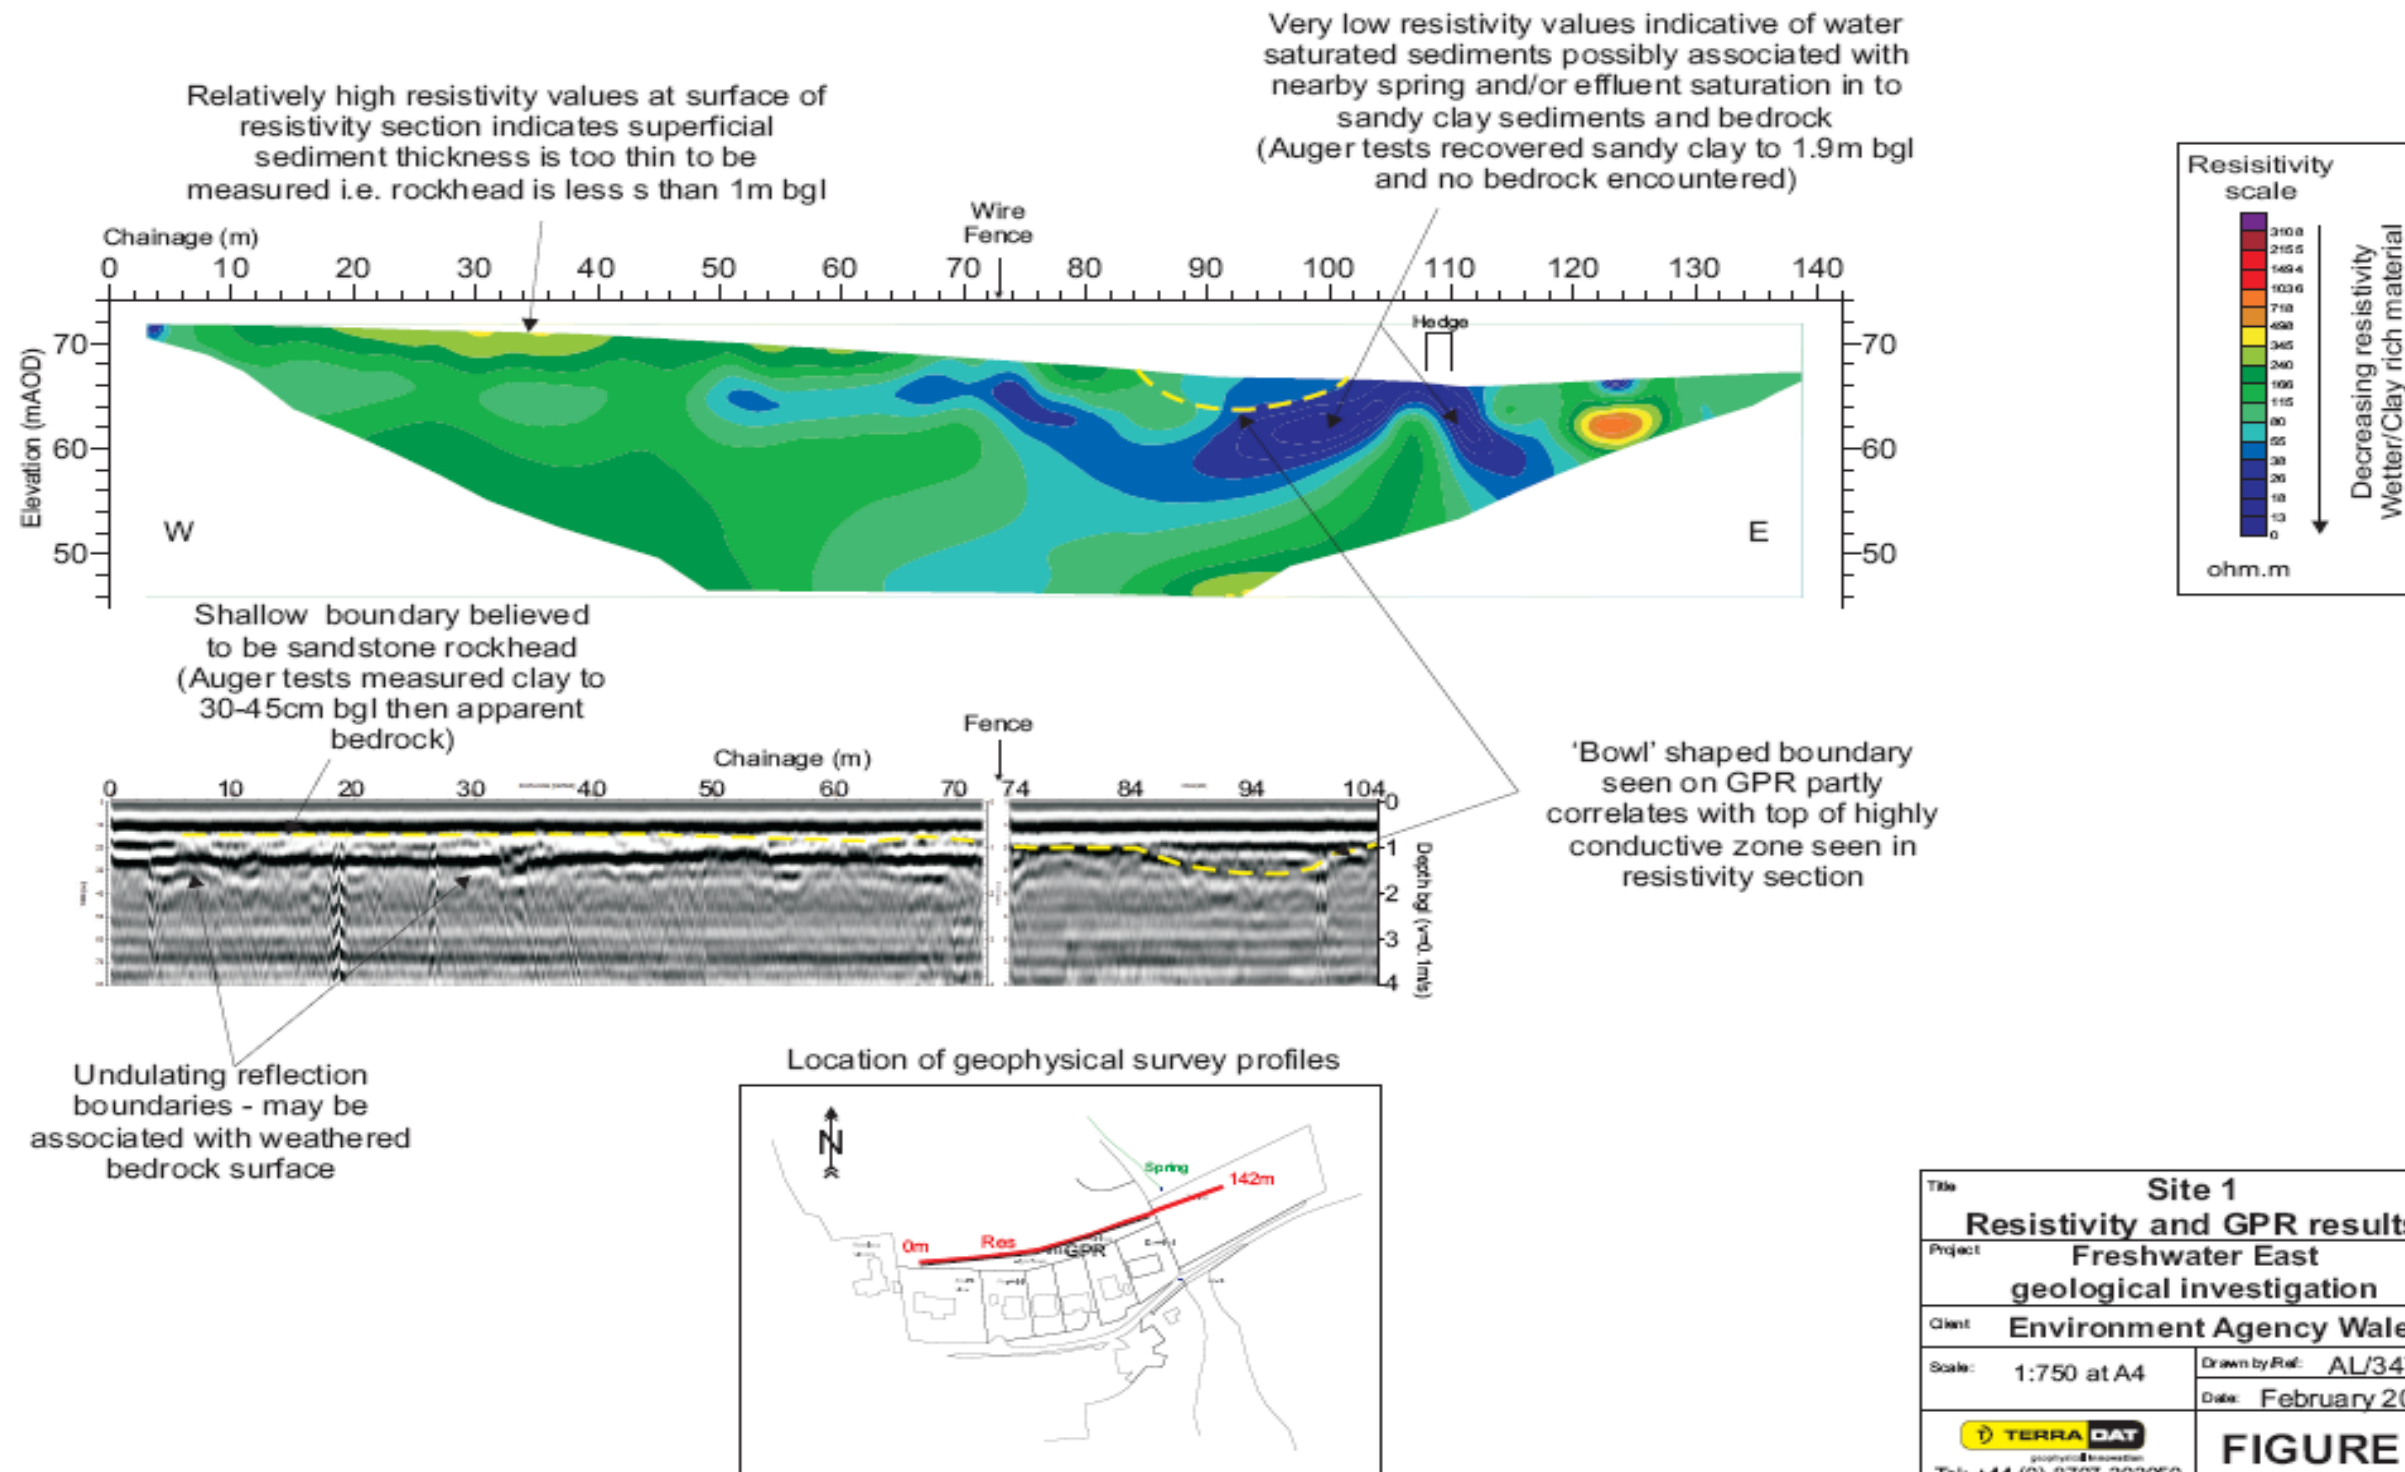
Figure 6 : Geophysical Cross Section 1. Rear of Jason Road

This comprised a 140m survey line (Figure 6) running almost east west behind the houses at the eastern end of Jason Road. This line was used to follow the rear of the properties where ponded effluent has been observed. Five hand augured holes were also made to compliment the geophysical work.

Investigations proved that the thickness of soil behind the houses ranged from 30-45 cm with bedrock encountered below. However in the area behind Eastfield (Site 21 – foul effluent) a 1.9m depth of clay was encountered. This would explain why foul effluent was ponding on the ground surface at this location.
