A477 Nash Fingerpost Junction Improvements

Stage 4 (12 month) Road Safety Audit

October 2016

Final Report

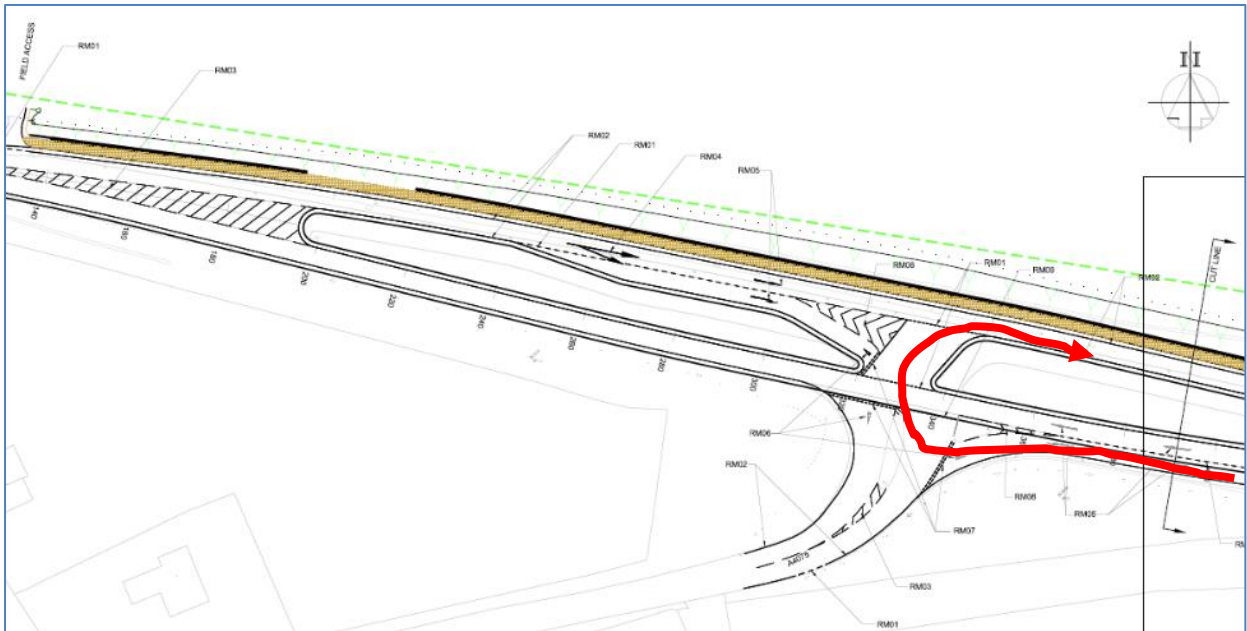
APPENDIX B: SCHEME DRAWING

- A car transporter accessing the Vauxhall garage in the direction of Milton was observed to undertake a complicated and non-standard U-turn manoeuvre including travelling the wrong direction through the exit onto the A4075 (see Appendix B) blocking the junction and creating potential conflicts with five different traffic movements at the junction. This led to queues of vehicles waiting to turn off the A477 in both directions. The manner in which the manoeuvre was carried out suggested this was regular practice.

Path of transporter vehicle observed by the Audit Team is shown by the red arrow
